## Atmospheric corrosion of nuclear waste containers

N.P.C. Stevens, A. Cook, S.B. Lyon and J. Duff  
Materials Performance Centre, University of Manchester  
(correspondence: stuart.lyon@manchester.ac.uk)

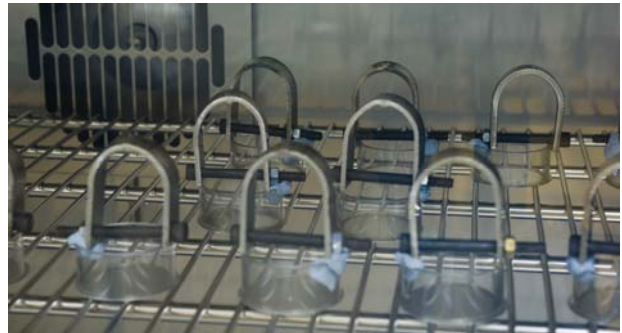
**Figure 1** U-Bend samples made from sectioned 316L waste drum material exposed in a humidity cabinet. The outer top surface is stressed to the yield point, and is loaded with salt at different deposition densities by droplet deposition.

The use of U-Bend and 'bow-tie' samples as shown in Figures 1 and 2 has allowed the possibility of SCC at lower temperatures than

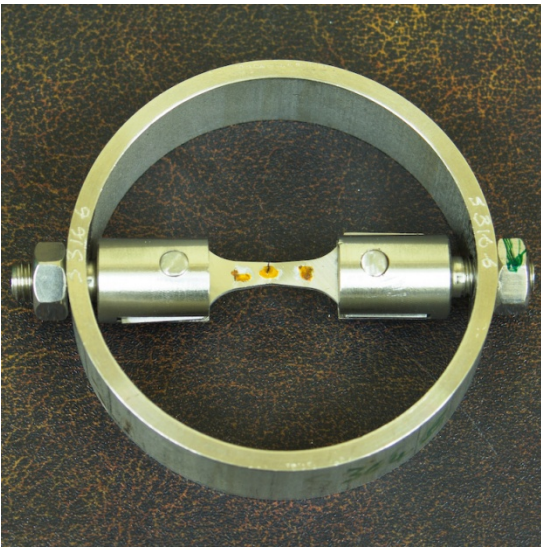
**Figure 2** 'Bow Tie' sample stressed by a proving ring, showing corrosion and cracking induced by contamination by salt droplets

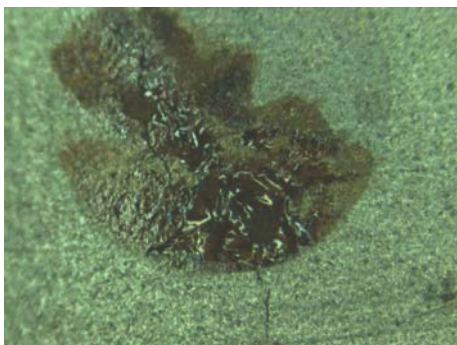
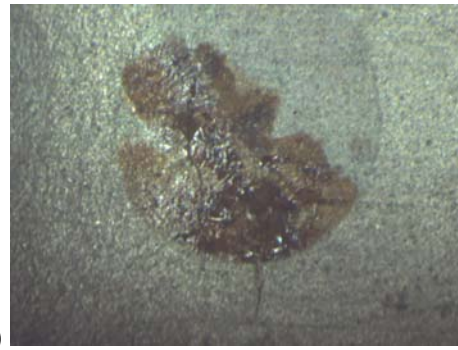
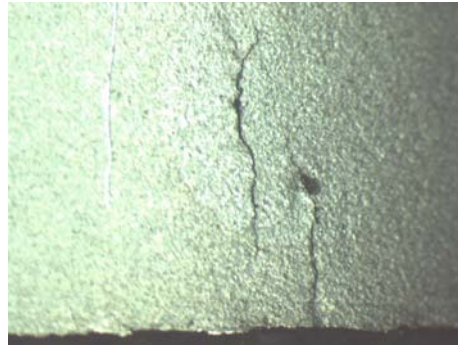
**Figure 3** Top surface of 316L U-Bend sample exposed at  $40^\circ\text{C}$ , RH: 30%,  $450 \mu\text{g}/\text{cm}^2$  deposited from a  $5 \mu\text{l}$  droplet of  $\text{MgCl}_2$ , Exposure time: a) 5 months and b), c) 12 months. Stress in vicinity of crack (apex of U – bend):  $\sim 600 \text{MPa}$ . c) shows sample after oxide removal.

A set of 316L U-Bend samples were contaminated with  $450 \mu\text{g}/\text{cm}^2$  deposit densities of salt from a  $5 \mu\text{l}$  droplet of  $\text{MgCl}_2$ . These were then exposed in a humidity cabinet at  $40^\circ\text{C}$ , and Relative Humidity 30%, with images taken at 5 and 12 months, when the corrosion product layer was cleaned off before final imaging. This final cleaning was carried out as on some of the samples, the corrosion products formed had obscured the cracks. Figure 3 shows a sample where the transition from corrosion to cracking was relatively easy to detect, and Figure 4 shows an example where the cracks were largely obscured by the surface salt and corrosion product loading.

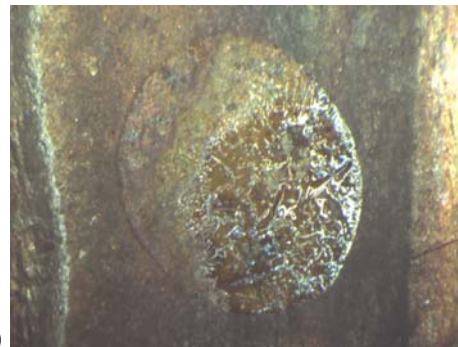
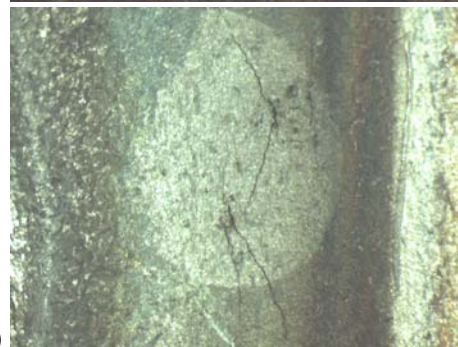
**Figure 4** Top surface of 316L U-Bend sample exposed at  $40^\circ\text{C}$ , RH: 30%,  $450 \mu\text{g}/\text{cm}^2$  deposited from a  $5 \mu\text{l}$  droplet of  $\text{MgCl}_2$ , exposed for 12 months a) before and b) after cleaning.

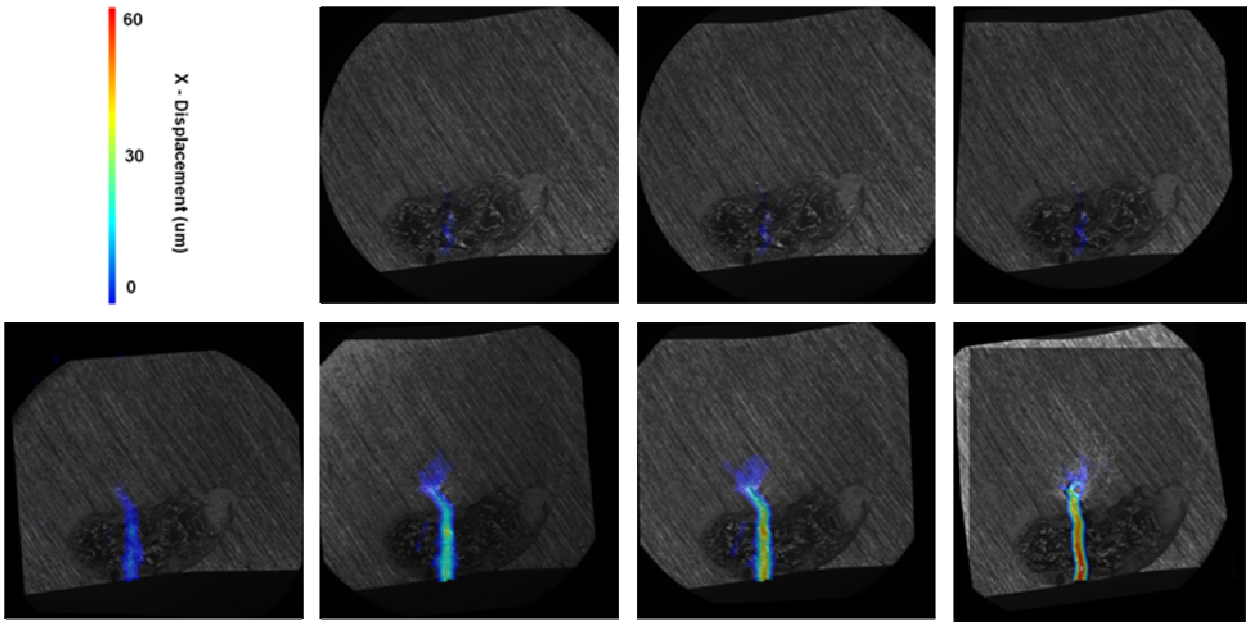
**Figure 5** Image series showing crack growth detected by DIC for SCC on a 304L tensile specimen recorded during exposure at 40°C and 30% RH at 1500 hours, 1668 hours, 1836 hours, 2004 hours, 2388 hours, 2676 hours, 3036 hours and 3232 hours (top left to lower right).

The use of DIC to monitor cracking processes in a qualitative way was discussed at DIAMOND 09. The facility of monitor the crack growth by measuring the crack opening allows the local behavior of cracks to be monitored, as shown in Figure 5. Using DIC to analyse the movement of regions remote from the crack itself also allows the overall relaxation of the sample to be detected. With the use of the proving ring to stress the sample, this leads to a reduction in the applied stress, The crack growth rates measured can therefore be correctly interpreted in light of the true stress and strain on the sample, as shown in Figure 6.

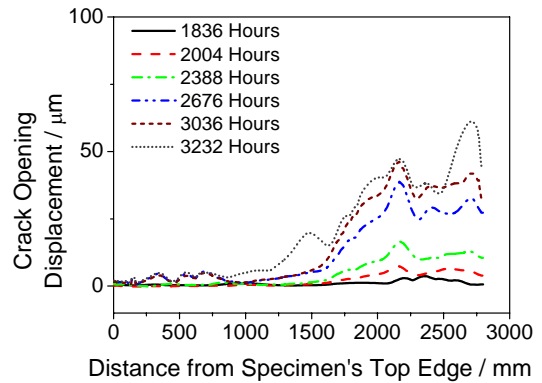
**Figure 7** Crack opening measured from sample top edge for sample shown in Figure 5

The crack opening displacements may also be extracted from the DIC analysis, and plotted as a cross section of the sample, as shown in Figure 7. This analysis offers the prospect of allowing the relationship between the mechanical force driving cracking, the stress intensity at the crack tip and the resulting crack growth rates to be investigated

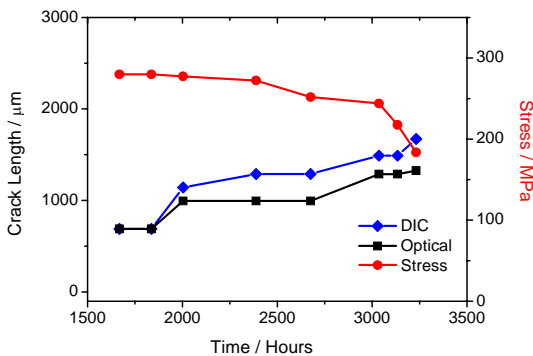
**Figure 6** Crack Length and Stress variation with time for samples shown in Figure 5
